Idaho National Engineering and Environmental Laboratory

SAPHIRE Use at NASA

April 10, 2003

Columbia Accident Investigation

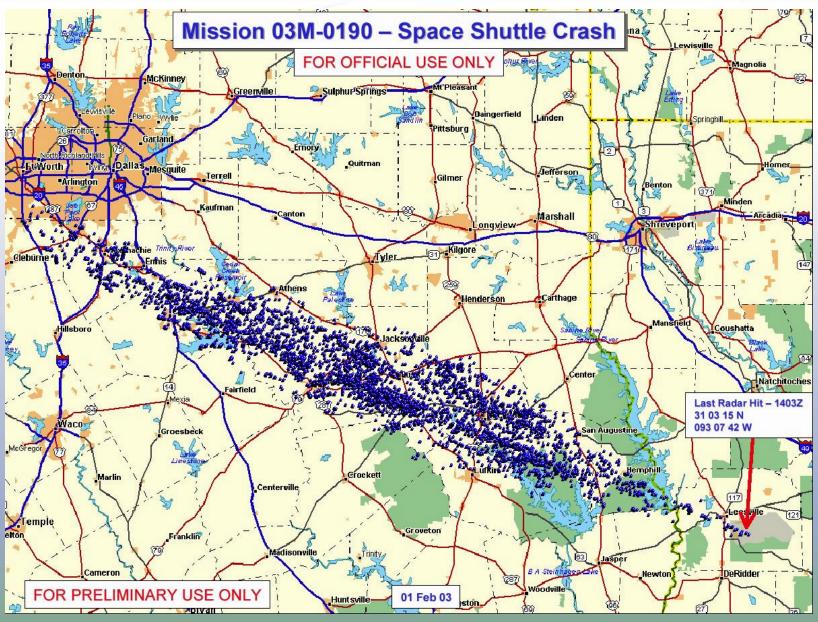
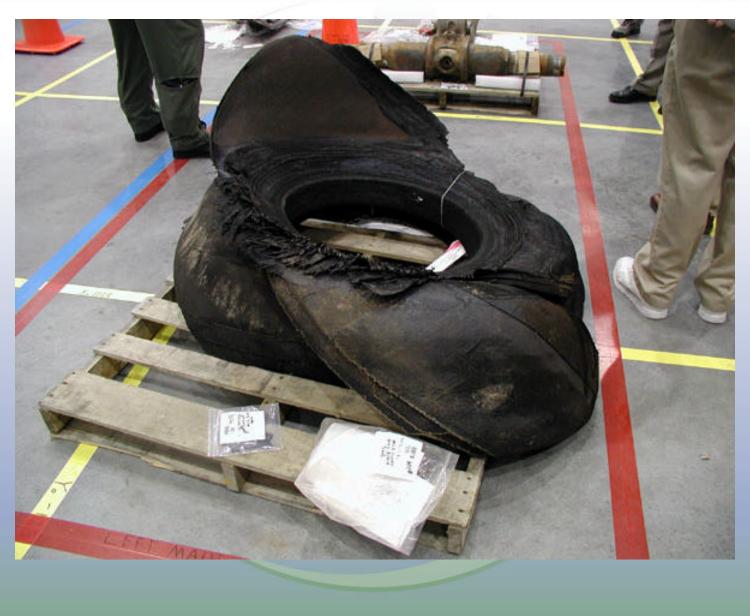
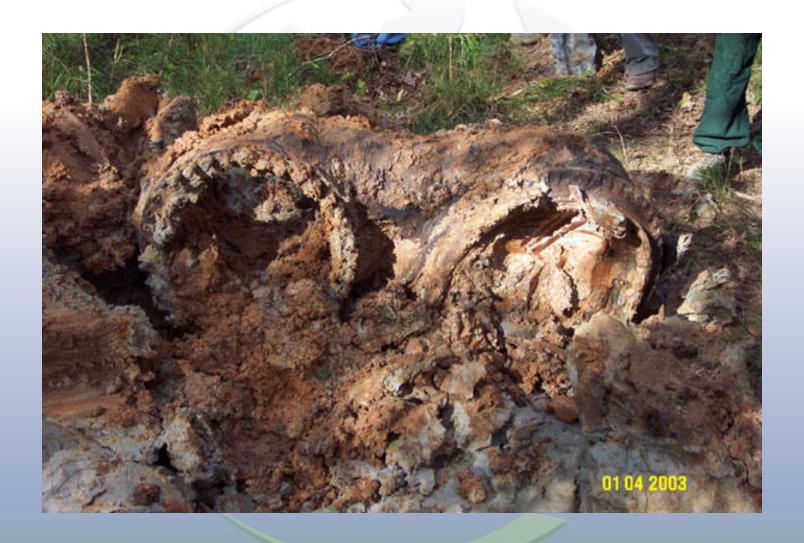
- Accident Scenario: Continued
 - 6:55:45 12th Report of Debris, Preceded and Followed by 2nd Plasma Trail
 - 6:56:16 Rapid Temp Rises in Wheel Well Temp Instruments
 - 6:56:24 First Indication of Instrument Damage Wing Skin Temp Goes Off-Scale Low
 - 6:56:30 Roll Reversal Initiated, 219K ft, Mach 20.9
 - 6:56:55 Roll Reversal Completed, Mach 20.76
 - 6:57:53-59 2 Flares of Orbiter Shape Observed Over NM
 - 6:58:03 Start of "Sharp" Aileron Increase Roll and Yaw Increases
 - 6:58:20 Altitude 209.8K ft, Mach 19.5, Crossing NM/TX Border
 - 6:59:32 Loss of Signal, Nothing More Heard From Columbia
 - Working: APUs, MPS, Fuel Cells, ME's, ECCLS, Body Flap, Right Wing
 - Failed: All Hydraulics, Left Elevon, Left OMS
 - 7:00:21 Main Body Breakup

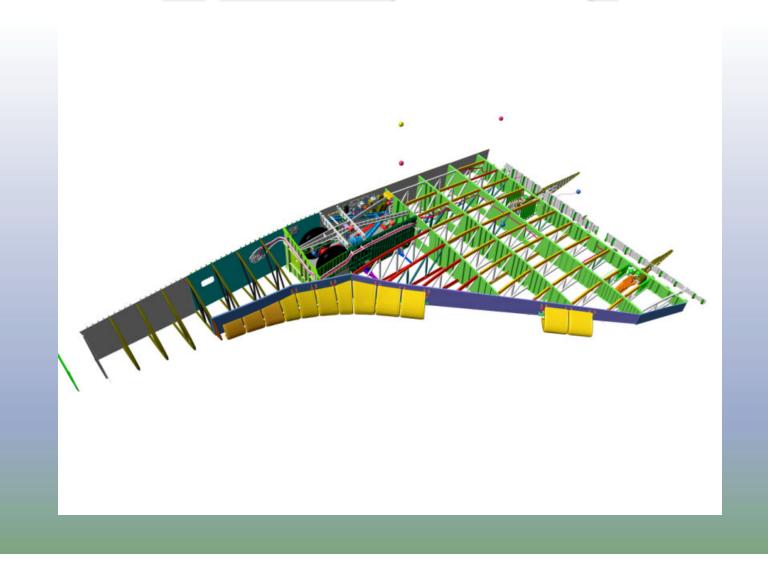
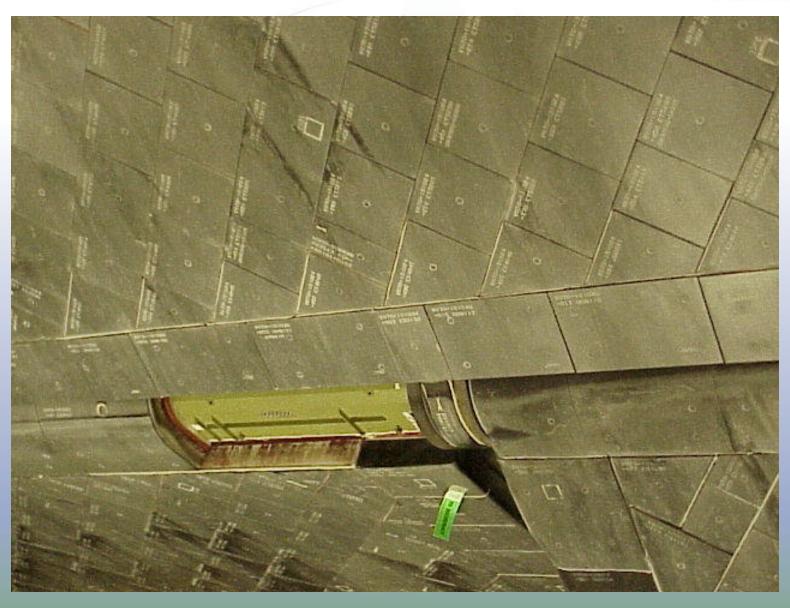
Concentrated on Left Wing
